SIO Shipyard Representative Bi-Weekly Progress Report		
Project: AGOR 28	Contract No.: N00014-12-C-0305	Shipyard: Dakota Creek Industries
Prepared by: Paul D. Bueren Scripps Institution of Oceanography (SIO) 297 Rosecrans St. San Diego, CA 98106	Date: December 4, 2014	Program Officer: Robert (Tim) Schnoor Office of Naval Research 875 Randolph St ONR 321 Arlington, VA 22203-1995
Distribution Statement A: Approved for public release; distribution unlimited.		Report No. A002.068

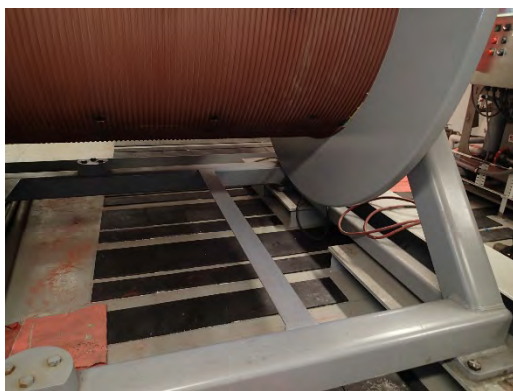
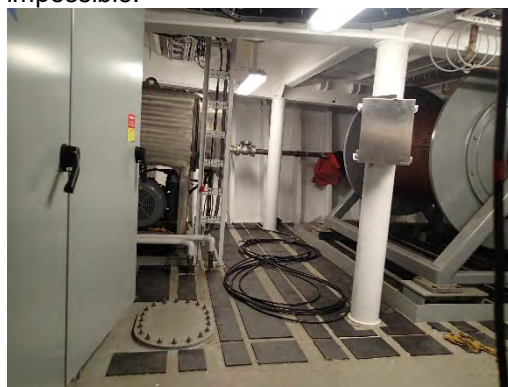
- Main Deck Vent Closures – Waiting to see how this is resolved by DCI & GPA.
- SSHD Controls – Drawings and manual indicate that operators will not have control of the SSHD from the Aft Control Station (locally known as the Bird House). This issue has been passed on to DCI and hopefully Markey/Allied. Markey's contractor Systems Interface was on board yesterday and I did ask about this. They were not aware of the issue at this time. Will continue to monitor.
- Tuff-Mass MLV and Acoustic Tiles - Awaiting resolution of smoke and flammability issues. Acoustic Tiles have recently been laid in the Traction Winch Room despite ongoing reg body issues. These tiles are going to make housekeeping in this space difficult, but not impossible.

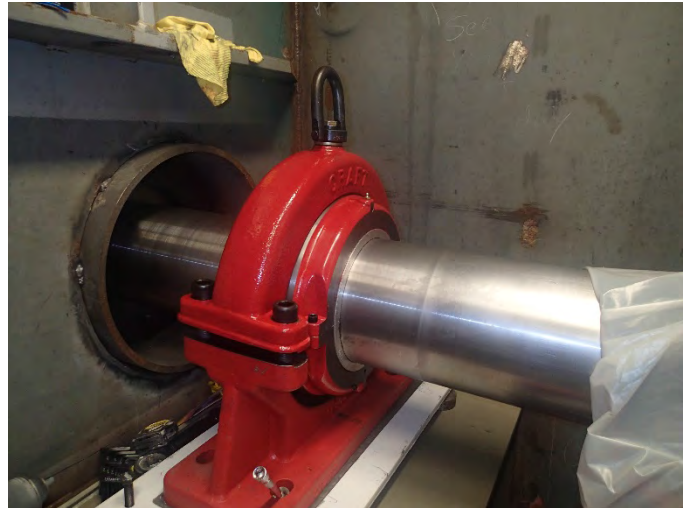
- Intermediate Shaft Bearings - Bearings have been installed on Ride's modified foundations. Alignment in progress on both vessels.

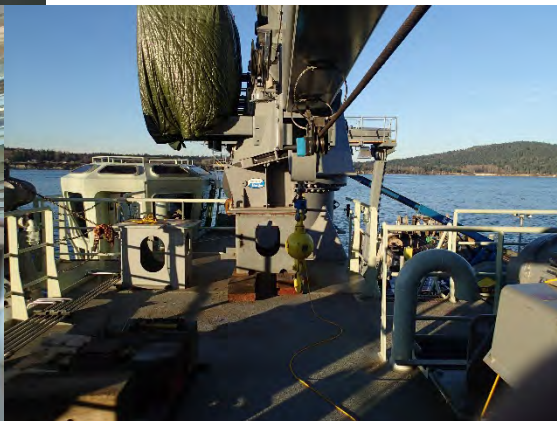
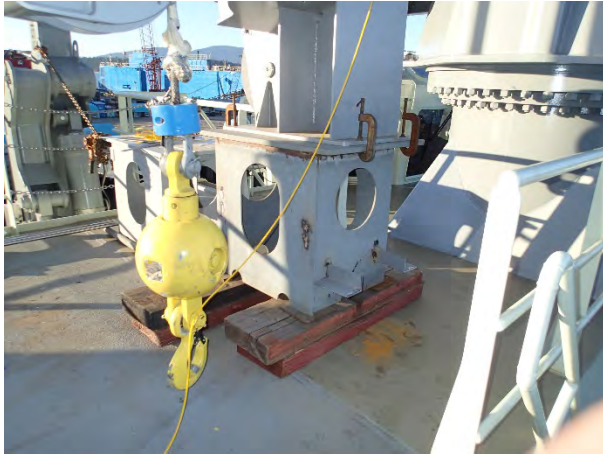
- Side & CTD Handling Systems – Unresolved issues with fairlead interferences from TK70-70 main crane remain. DCI is using Sally Ride's aft fairlead foundation to test various new locations on Armstrong. Ride's foundation was not permanently fixed so this is acceptable. The foundation was moved laterally to a position just inboard of the crane's boom and raised approximately 8-inches. This will allow the wire from the aft winch to pass aft of the crane's snout. It also appears that the forward winch will also be able to utilize this change in configuration. No permanent changes should be made until both winches and handling devices are operational. For the fwd winch and CTD handling device, issues still remain in regards to possible interference with the crane's winch and crutch. These can best be verified once the winches and handling systems are operational.

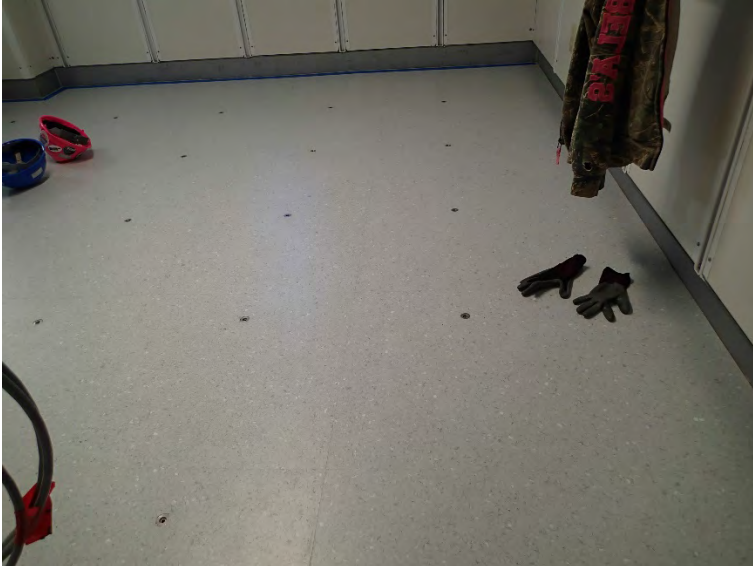
- Deck Coverings – Tile has been installed over the Dexotex in Armstrongs ET Shop and the yard is prepping the Dexotex for tile in the Computer Lab. The look and fit appears to be excellent.

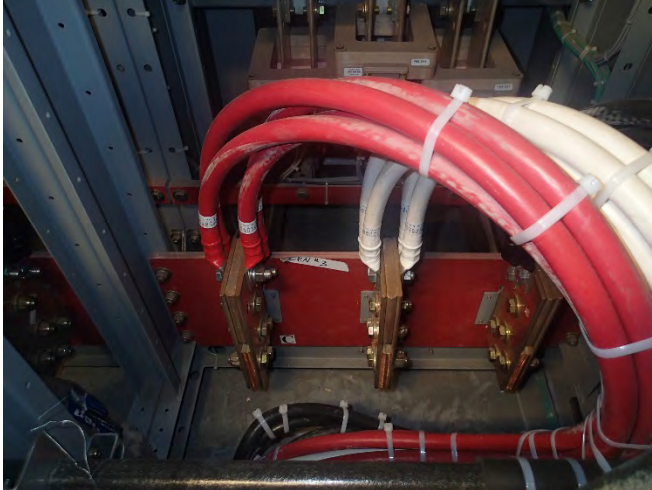
- TK70-70 Main Crane – The welding of the crane's foundation to the deck has been completed.
- Sally Ride Electrical – Work continues at a good pace with connection now being made at the 690-vac and Emergency Switchboards. Electrical work is being done on all decks.
